Extract of dissertation titled:

‘Are the Building Regulations fit for the purpose of upgrading traditional, historic and listed buildings using modern applications in Wales?’

Author: Anthony Gwynne, MSc (Dist), MRICS, IHBC, MIFireE

Appendix A: Case studies confirming guidance in Approved Documents is being inappropriately applied to traditional, historic and listed buildings some with unintended consequences

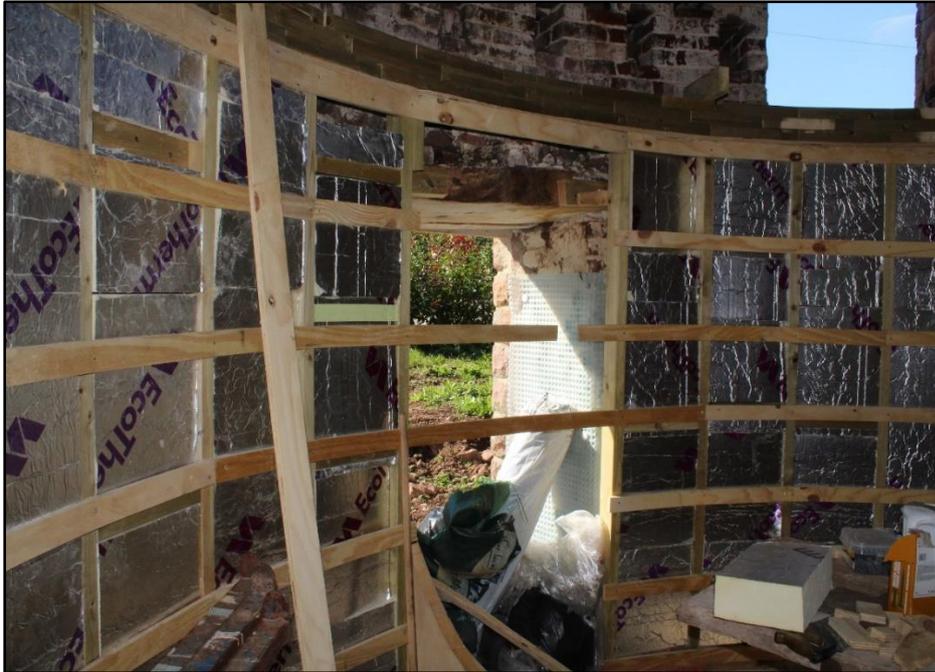
Case study 1: Conversion of Grade II listed dovecote into holiday let in 2018.

Figure 1: Upgrading of solid walls with modern non-vapour permeable tanking membranes and high density polyisocyanurate insulation board (Source: Gwynne 2018).

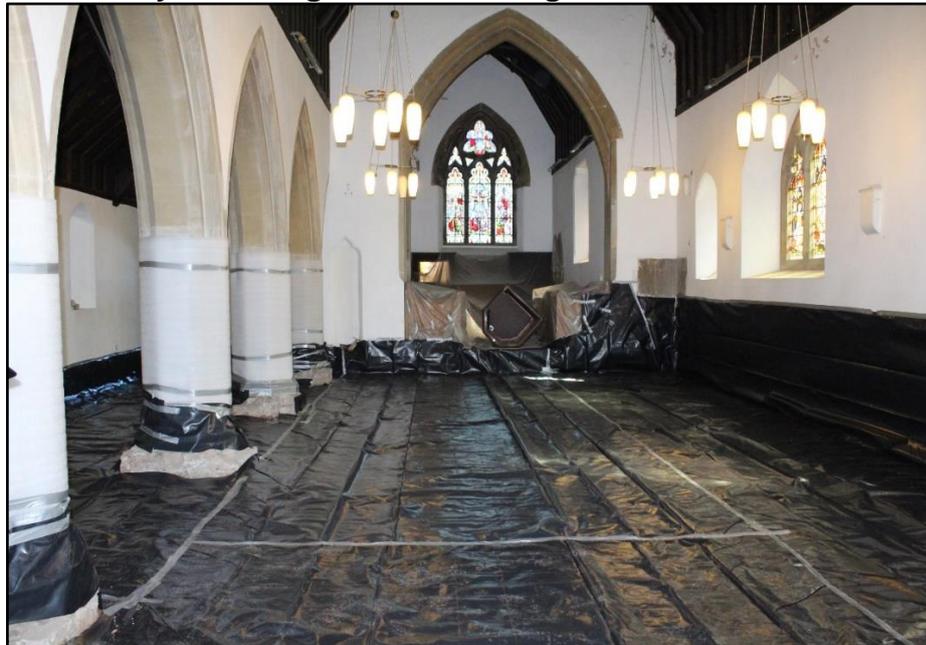
Case study 2: New ground floor to grade II listed church in 2019.

Figure 2: Polythene damp proof membrane laid over the floor area and dressed up walls (to hide existing rising damp) ready to receive 100mm thick high-density polyurethane insulation board, 100mm dense concrete slab and ceramic tiles (Source: Gwynne, 2019).

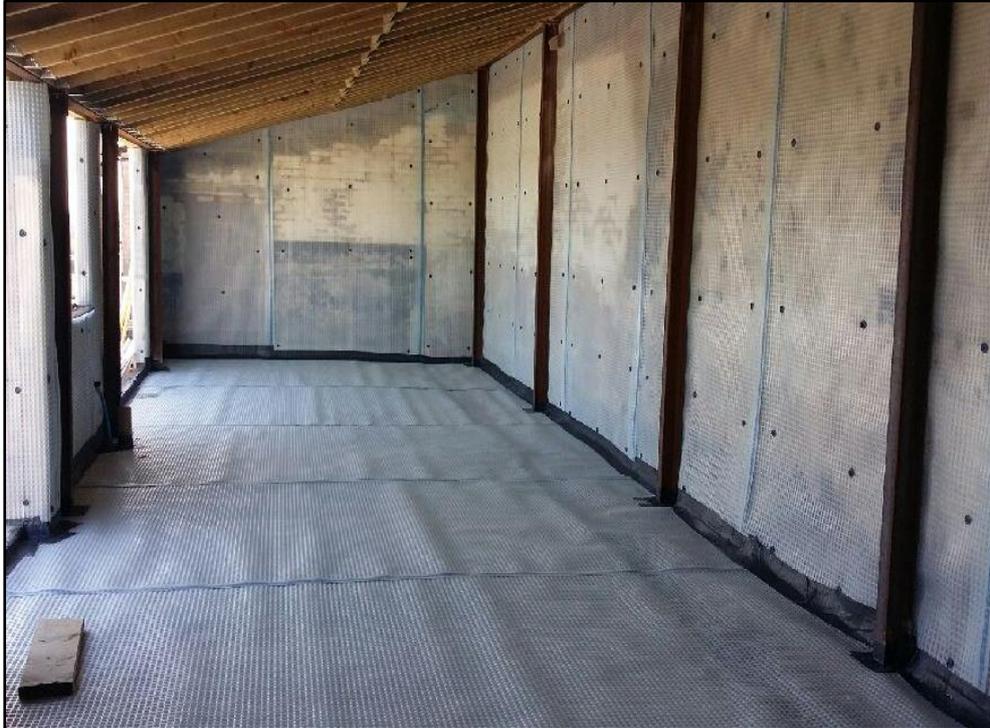
Case study 3: Conversion of stables into holiday let in 2018.

Figure 3: Water proof tanking system fixed to top of original floor and internal face of solid stone walls to prevent damp ingress ready to receive a high density polyisocyanurate insulation board and concrete slab to floor and same insulation fixed between timber stud walls with vapour checked plaster board fixed around the inside perimeter (Source: Gwynne, 2018).

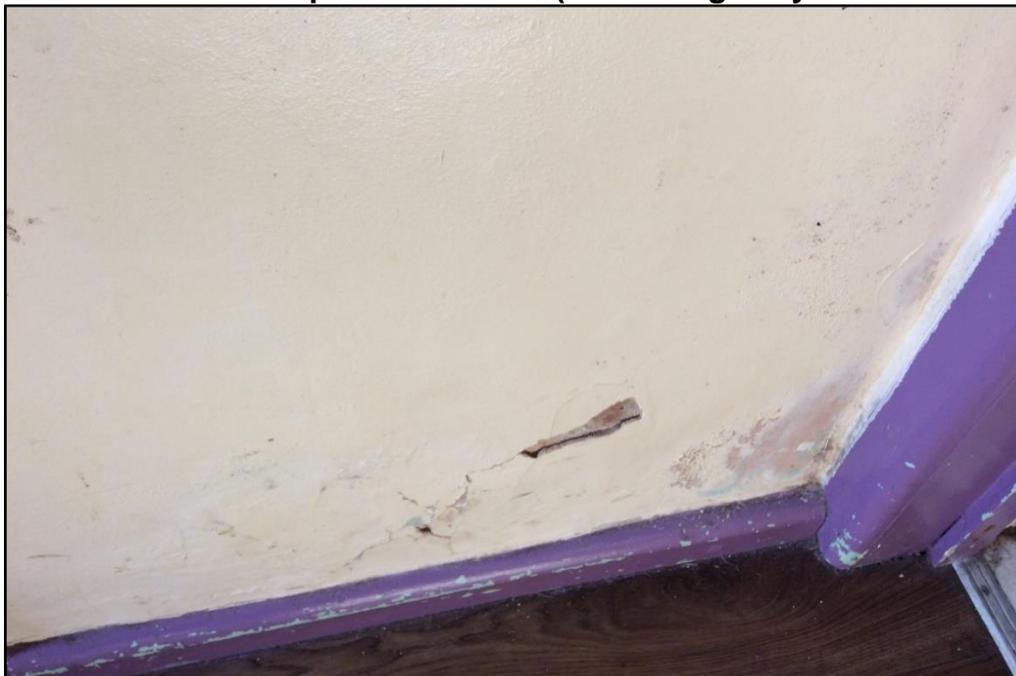
Case study 4: Damp in solid house walls renovated with hard non- permeable cement render and plaster finishes (works originally carried out in 2009).

Figure 4: Rising damp and Crypto fluorescence pushing off hard gypsum plaster (Source: Gwynne, 2017).

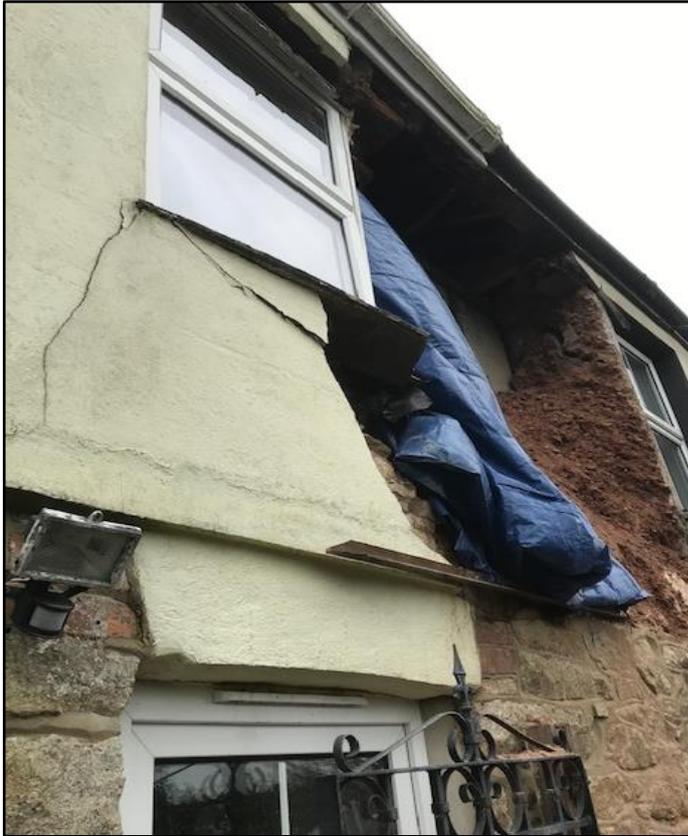
Case study 5: Collapsed cob walling -renovated with hard non- permeable cement render and internal plaster board finishes in December 2019.

Figure 5: Collapse of the cob wall caused by water trapped behind hard cement render (Source: Gwynne, 2019).
